# **Localised Failure of Cliff Top Waitemata Group Residual Soils, an Approach to Remediation**

**Andrew Gordon**

*WSP Opus, 100 Beaumont Street, Auckland, New Zealand*

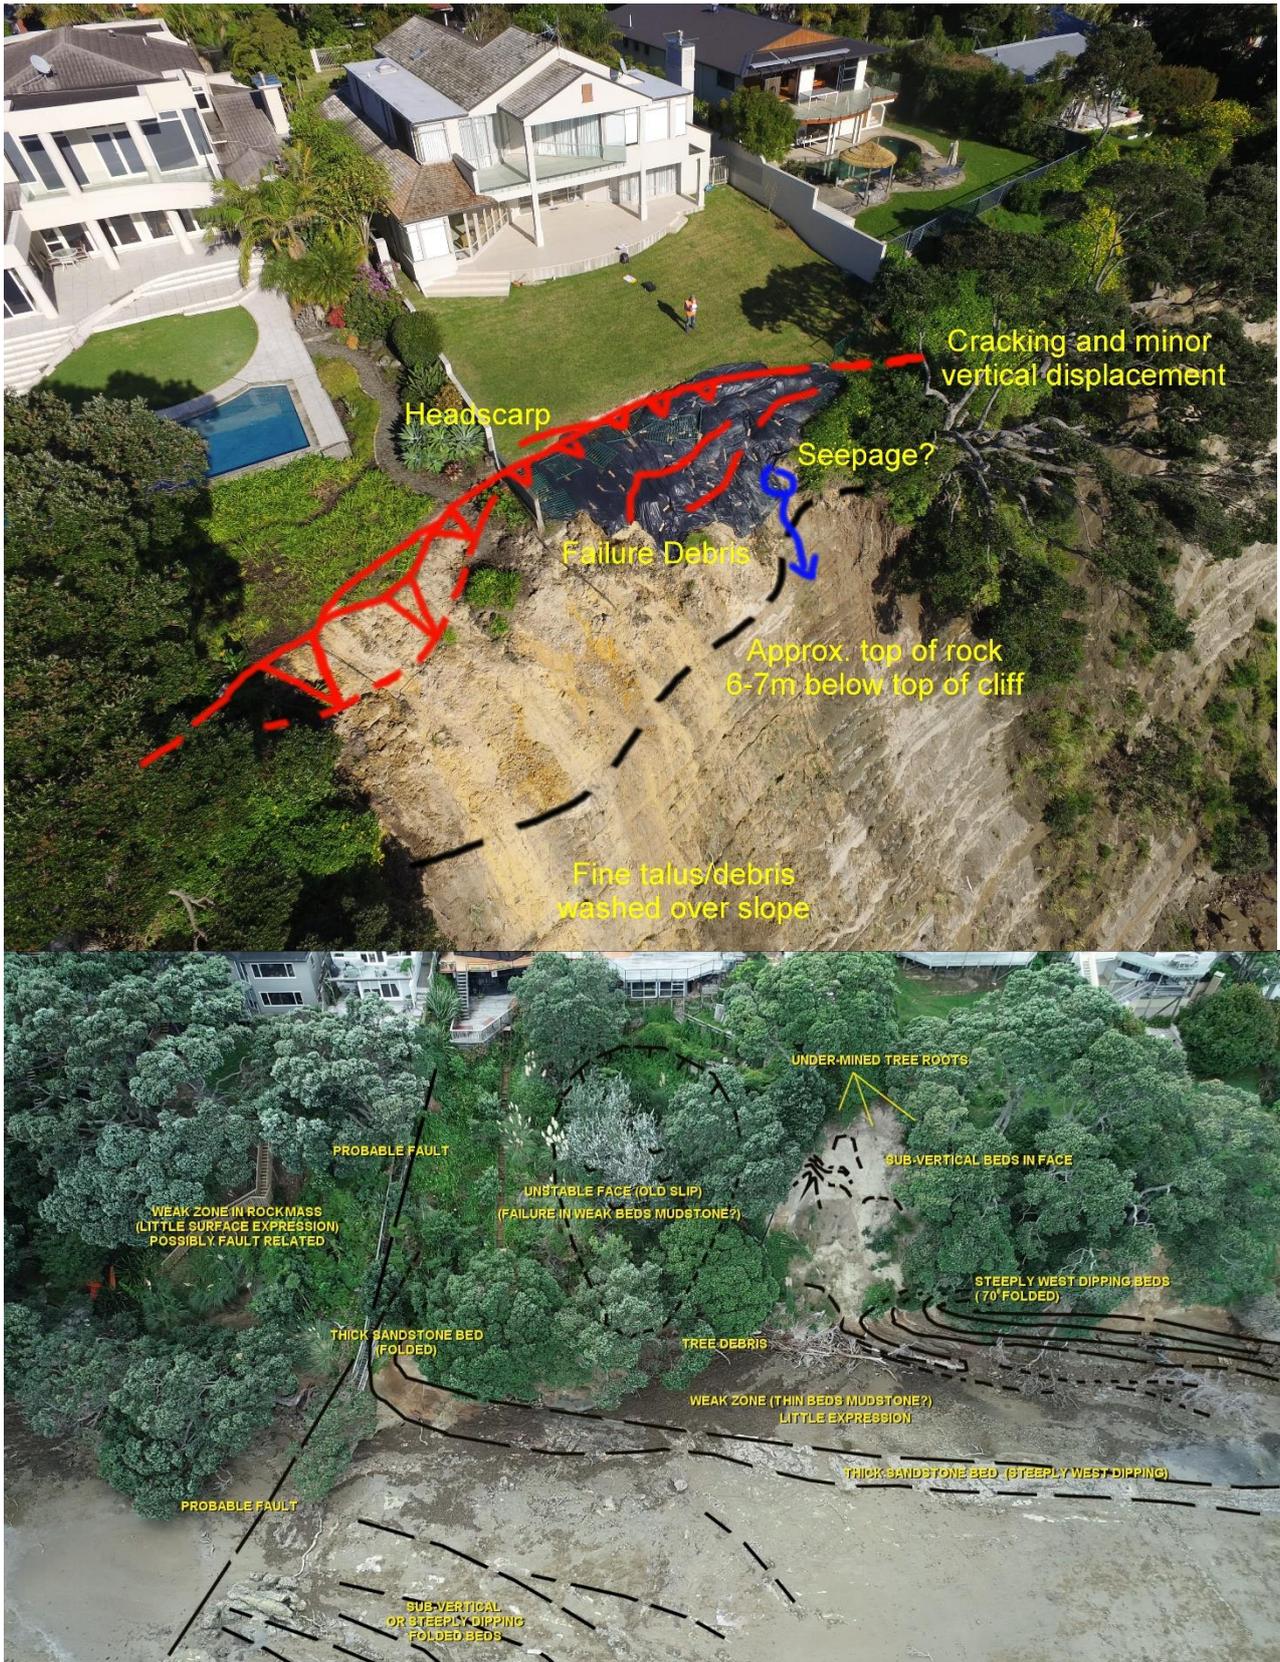
The Waitemata Group typically has contorted bedding and highly faulted. The contorted bedded is inferred to be the result of soft sediment deformation post deposition. The spatial variability of bedding and faulting is significant, due to its effect on the erosion processes and subsequent cliff line retreat (Moon and Healy, 1994) (Figure 2).

Figure 2: Examples of terrain evaluations produced from UAV photography. A) Typical soil failure observed along cliff tops in the Auckland Area. B) The variability of the East Coast Bays Formation geologic structure, the influence of the underlying geological structure of soli failures is important.

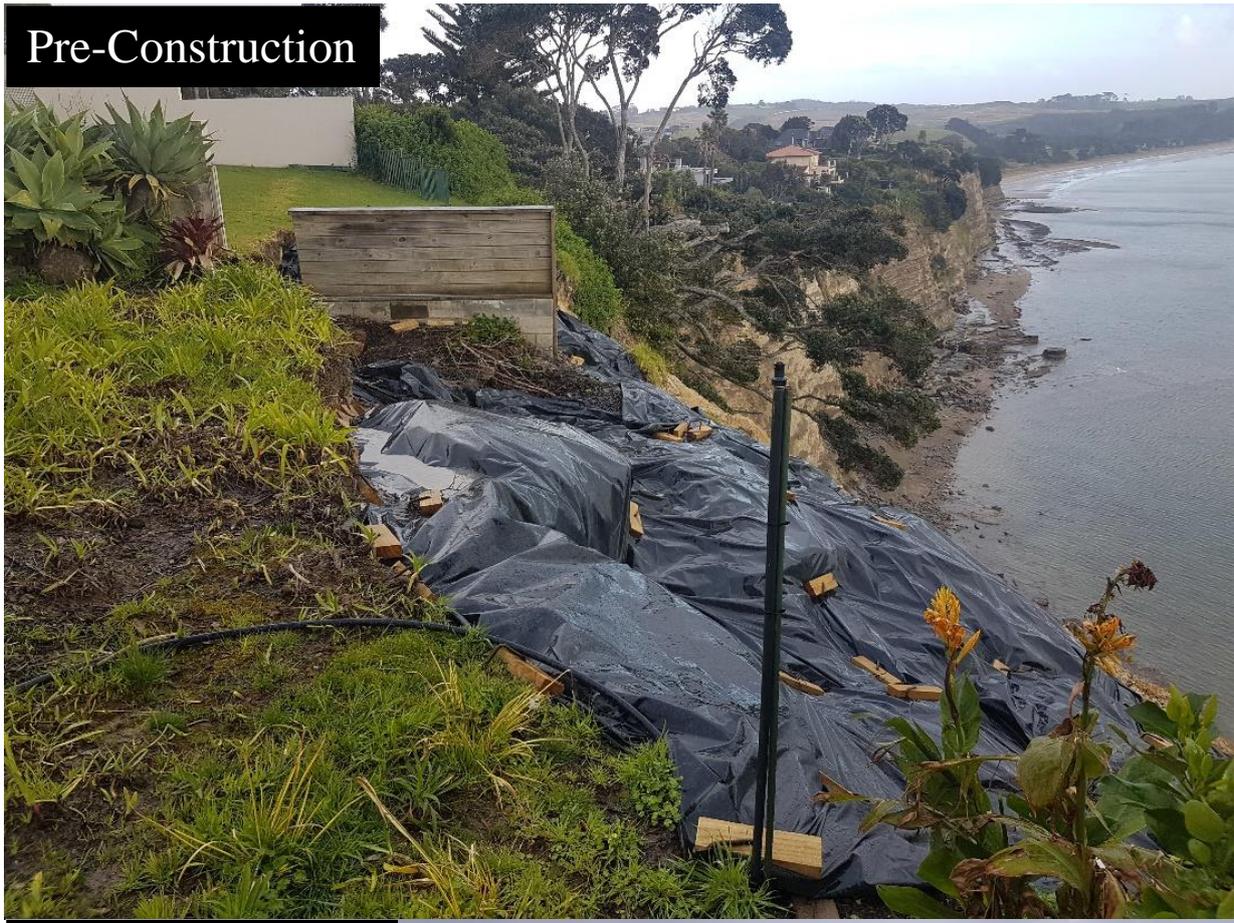
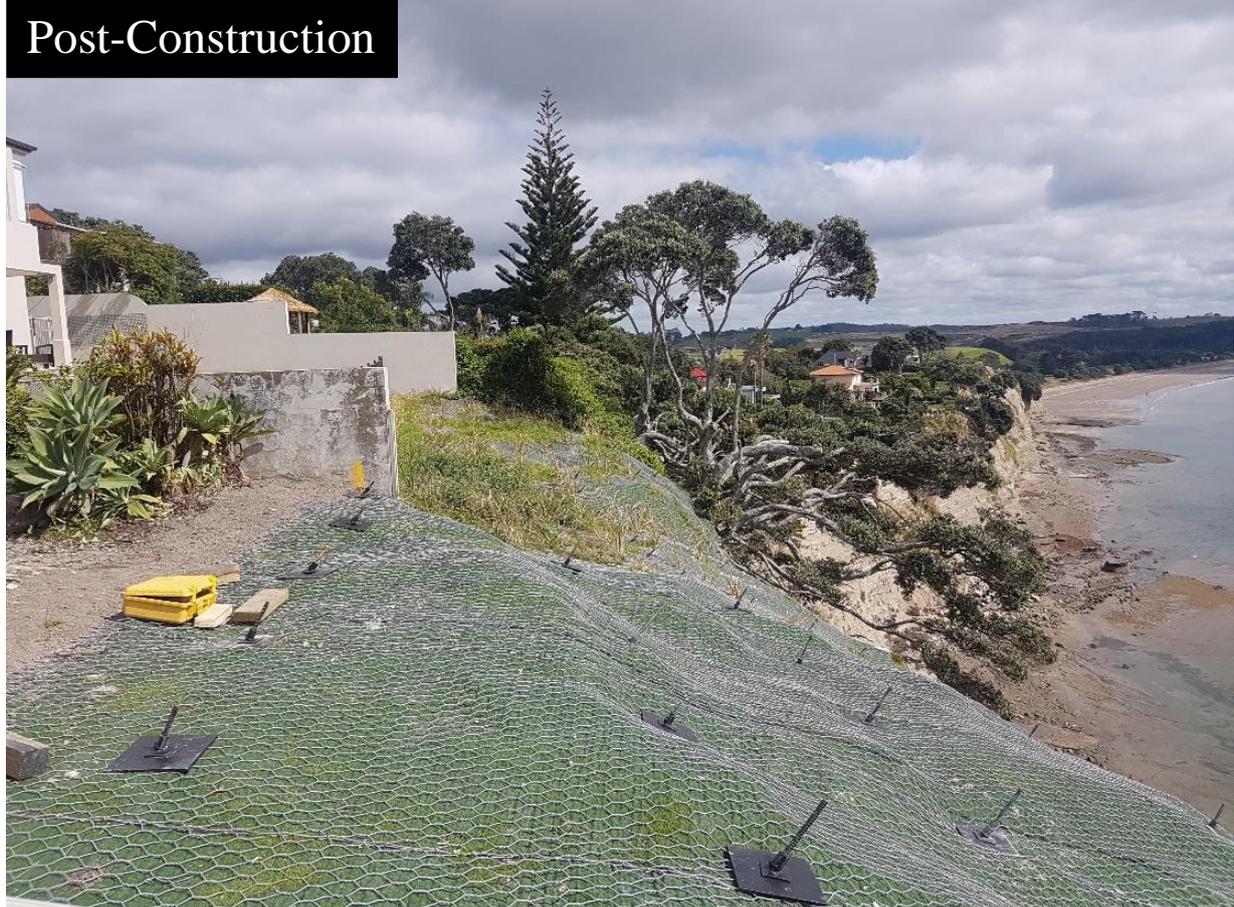
Figure 3: Pre-and post-construction photos of the site in Figure 2a of a soil-nailed slope remediation. remediation was undertaken in two stages across a property boundary a few months apart, notice the rapid revegetation of the distal slope

- The wishes of the landowner, if their budget allows, they may seek to reinstate a portion of the lost material in order to maintain the extent of useable land use area, or also to stabilise the soil mantle in front of a wall, or may just wish to stabilise the head scarp of the failure, while provide an aesthetically pleasing solution (Figure 3).
